Stoney Creek Urban Boundary Expansion (SCUBE) West Subwatershed Study
Phase 1 and Phase 2 Final Report

May 15, 2013

AQUAFOR BEECH LIMITED

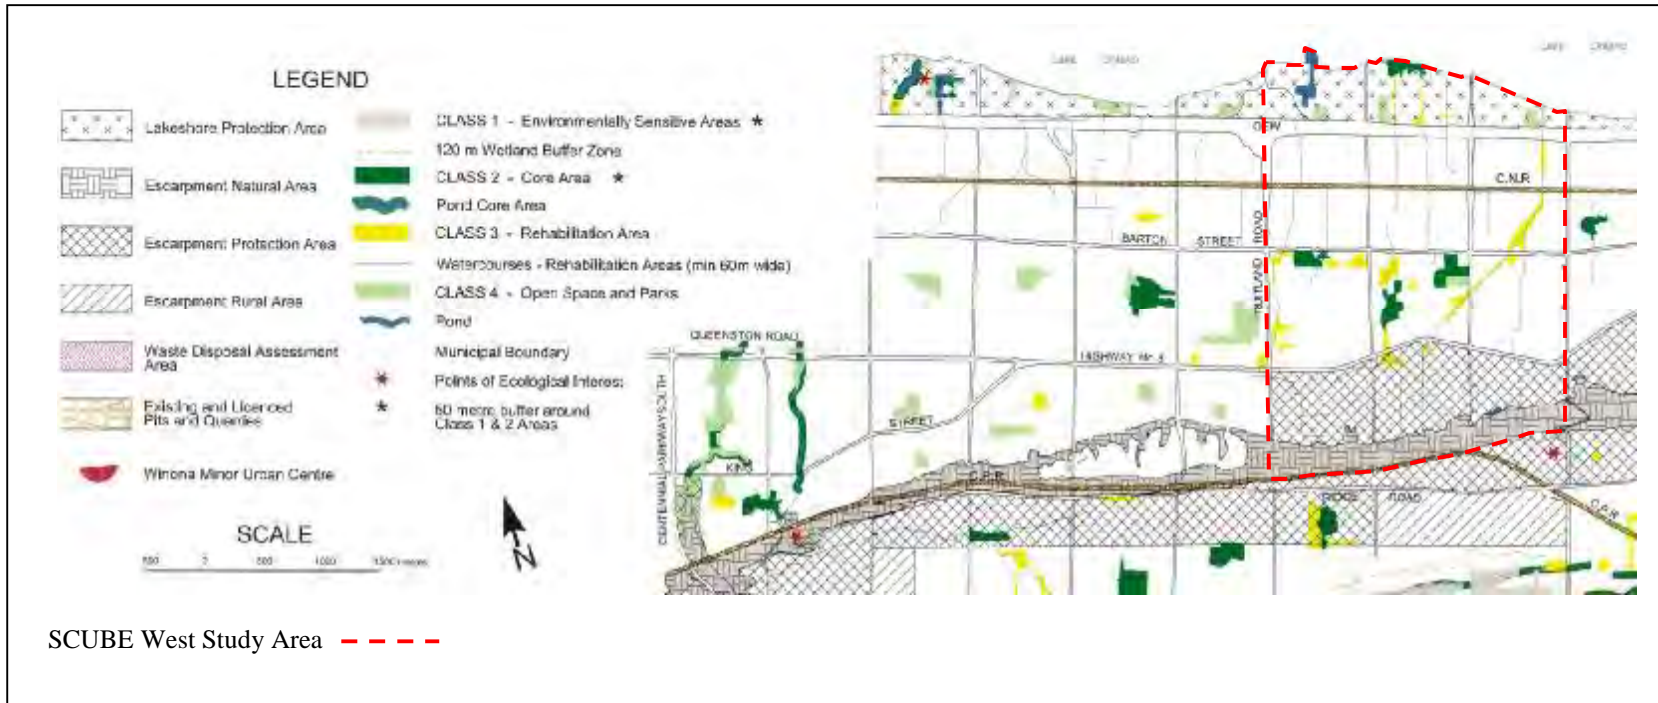
Figure 3.2: Excerpt of Schedule B of Town of Stoney Creek Official Plan showing the study area of the SCUBE West Subwatershed Study.

Schedule B of the Town of Stoney Creek Official Plan illustrates the SCONES lands. Within the study area of the SCUBE West Subwatershed Study, these include a single Class 1 feature (the Regionally-designated Devil's Punch Bowl Escarpment ESA), four Class 2 features and a number of Class 3 and Class 4 features. The majority of the Class 2 and Class 3 features are located within the portion of the study area that is subject to the Fruitland-Winona Secondary Plan (Figure 3.2).

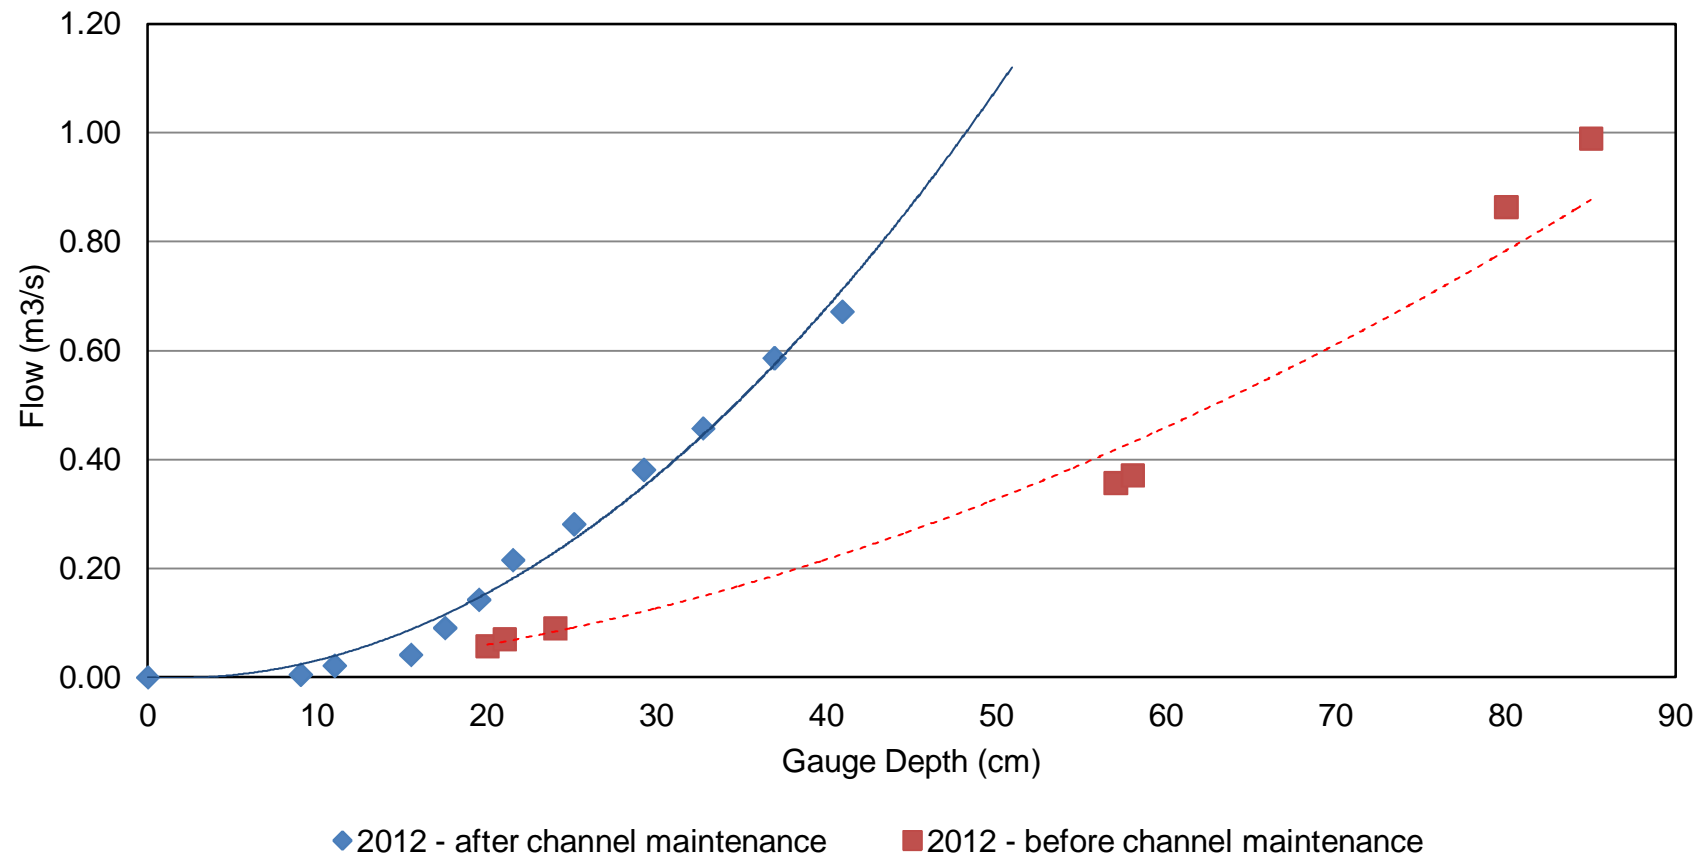
**FIGURE 3.5: Watercourse 5 Streamflow Gauge
Rating Curve Development**

As part of the monitoring program, spot flow measurements were undertaken and correlated to the water level measurements at the two streamflow gauge sites in order to develop rating curves for each location. Part way through the monitoring period, on 03 July 2012, maintenance activities were undertaken by the city to clear debris and vegetation from the channels. As a result, two sets of rating curves were developed for each gauge; one for the period of record before the channel maintenance works and one for the period after the works. The resulting rating curves are illustrated in Figure 3.5 and Figure 3.6. As shown, sufficient spot flow measurements were taken to develop representative rating curves at both locations. These rating

curves were used to translate the water level monitoring data into hydrographs for use in model calibration.

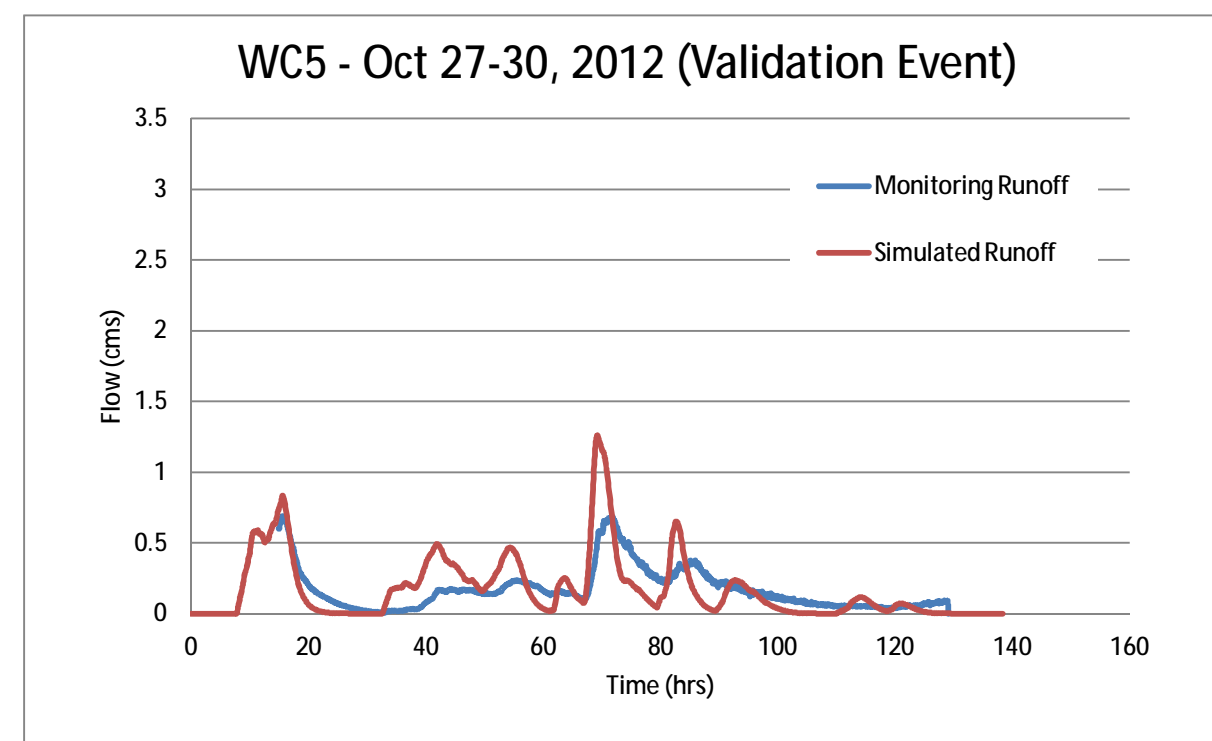
FIGURE 3.7: Hydrologic Model Calibration-Validation Results - Watercourse 5

As illustrated, good results were obtained through calibration, with the simulated peak flow rates within approximately $0.5 \text{ m}^3/\text{s}$, or less, of observed values for all events at both gauge sites. In

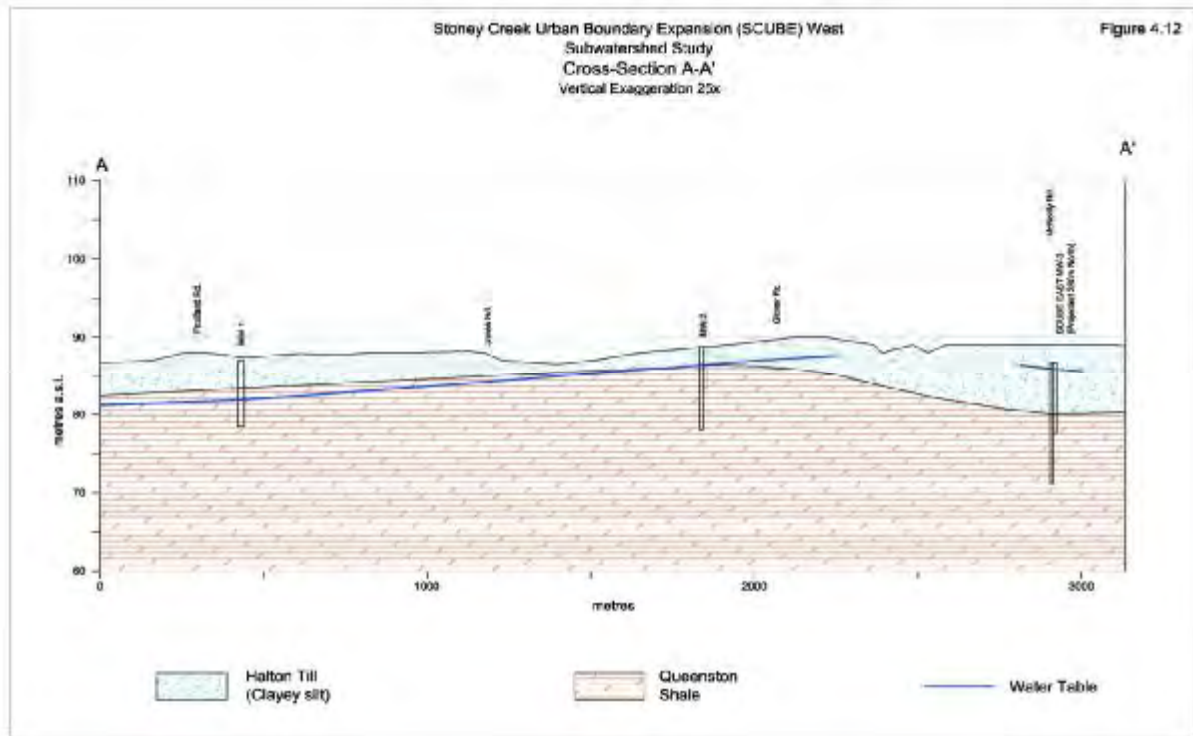
Figure 3.12: SCUBE West cross-section A-A' (east-west)

The geology of the Study Area is illustrated in Figure 3.11, and geologic cross-sections are illustrated in Figure 3.12 and Figure 3.13. As shown, the southern portion of the Iroquois Plain through the study area is characterized in large part by shallow bedrock with a relatively thin layer of Halton Till, often less than a metre in thickness and thickening to the north to 3+ metres.

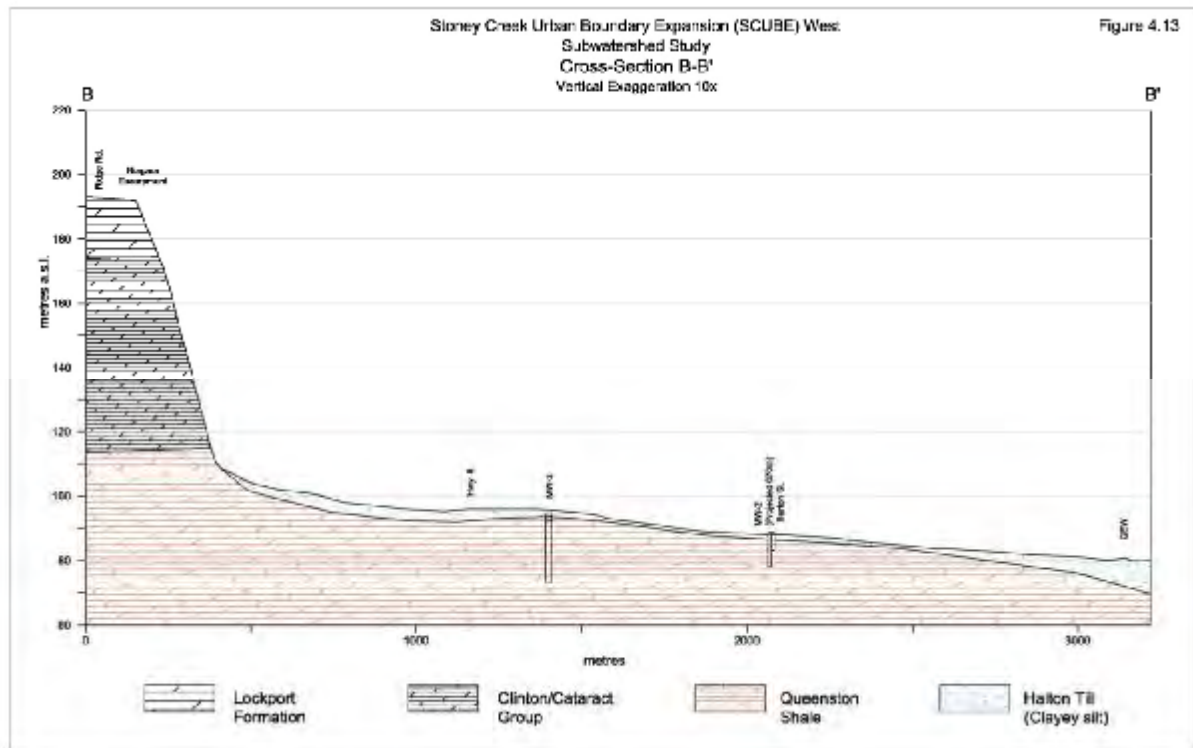
Figure 3.13: SCUBE West cross-section B-B' (north – south)

Within the northern portion of the subwatershed, beginning north of Barton Street and extending to the Lake Ontario shoreline, the bedrock shelf drops off rapidly. Immediately north of the QEW, the Halton Till thickness exceeds 20 metres.

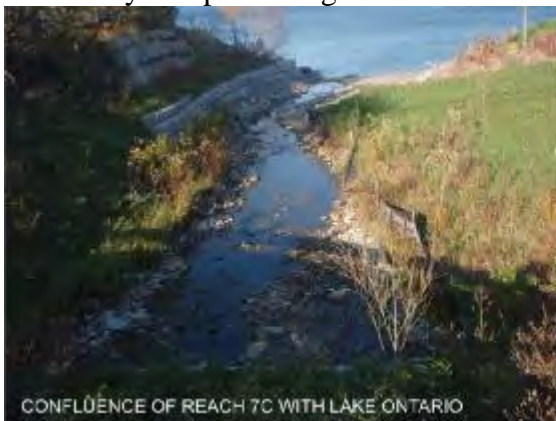
CONFLUENCE OF REACH 7C WITH LAKE ONTARIO

This reach is confined between two 3 m high armourstone retaining walls approximately 9 m apart. A recently constructed alluvial channel meanders back and forth between the retaining walls, with a riffle-pool morphology. Vegetation is growing within the corridor, however, not mature enough to provide cover to the low-flow channel. The channel bed and banks are predominantly composed of gravel and cobble size roundstone, and remain stable.

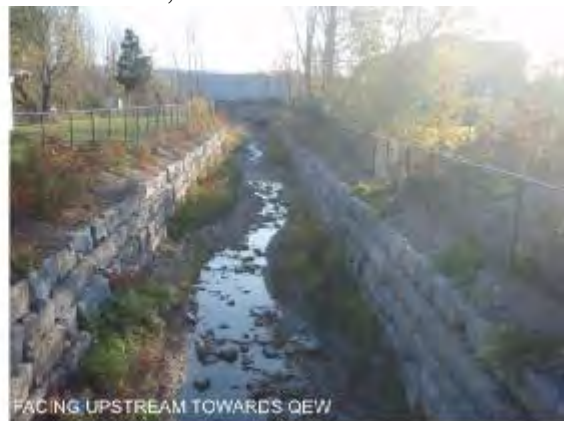
FACING UPSTREAM TOWARDS QEW

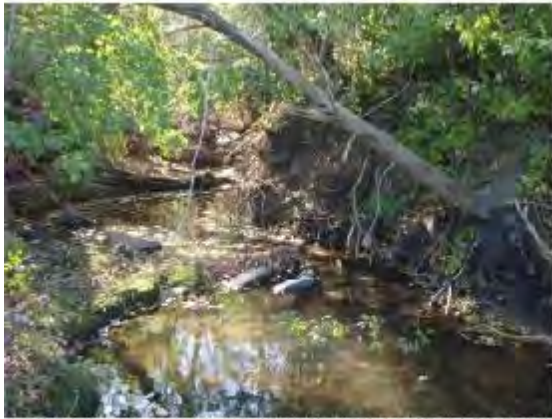
INCISED CHANNEL UNDERGOING PLANFORM DEVELOPMENT

The watercourse upstream of the QEW is incised and is gradually undergoing planform development. Erosion was noted along the right bank (facing upstream) with minimal risk to the industrial infrastructure or property on the table lands. Flows through this reach were at extremely low velocities, indicating erosion only occurs at high flood levels. The banks were well vegetated with mature riparian cover for the majority of the reach, however, the corridor was less than 15 m in width. Where the channel crosses the CN Rail line a grade control

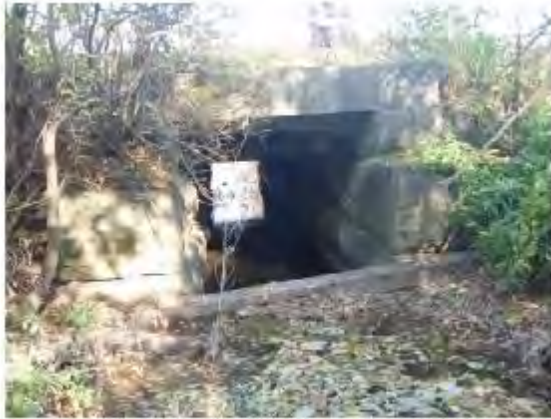
GRADE CONTROL AT CN CULVERT CREATING BACKWATER CONDITIONS

structure is encountered upstream of the culvert. This creates backwater conditions upstream for over 50 m, flooding the corridor and depositing fine sediment. Downstream of the grade control the morphology was dominated by long pools with short riffles. Overall the reach was classified as moderately stable, with minor erosion upstream of the QEW.

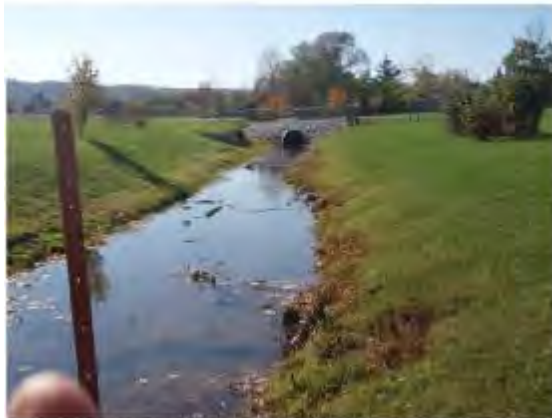
LOW GRADIENT CHANNEL WITH LONG POOL FEATURE AND MANICURED BANKS

This reach is heavily influenced by the residential neighbourhood south of Barton Street. The downstream extent of the reach is lined by manicured grasses and straight in planform for approximately 150 m. Until the headwaters the reach the flows through residential yards with intermittent bank treatments and private crossings. Many long pools were identified between private culverts and crossings, indicative of a low-gradient channel. Channel treatments are used to maintain the straight planform as residents have built structures to the top of bank throughout. The reach was generally stable with minimal erosion.

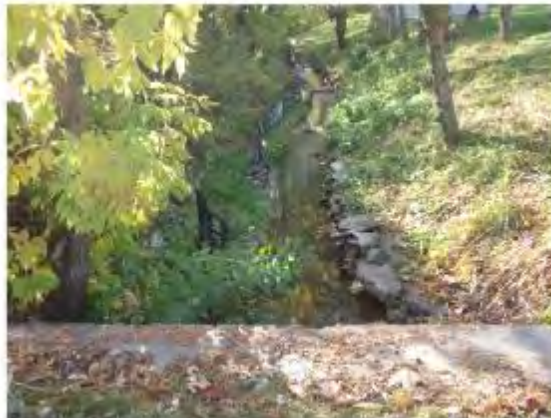
NARROW CHANNEL THROUGH RESIDENTIAL NEIGHBORHOOD WITH INTERMITTENT BANK TREATMENTS
